Xi Motor DONGLE Update

8M4005956 Rev A (Kit 8M4006087)

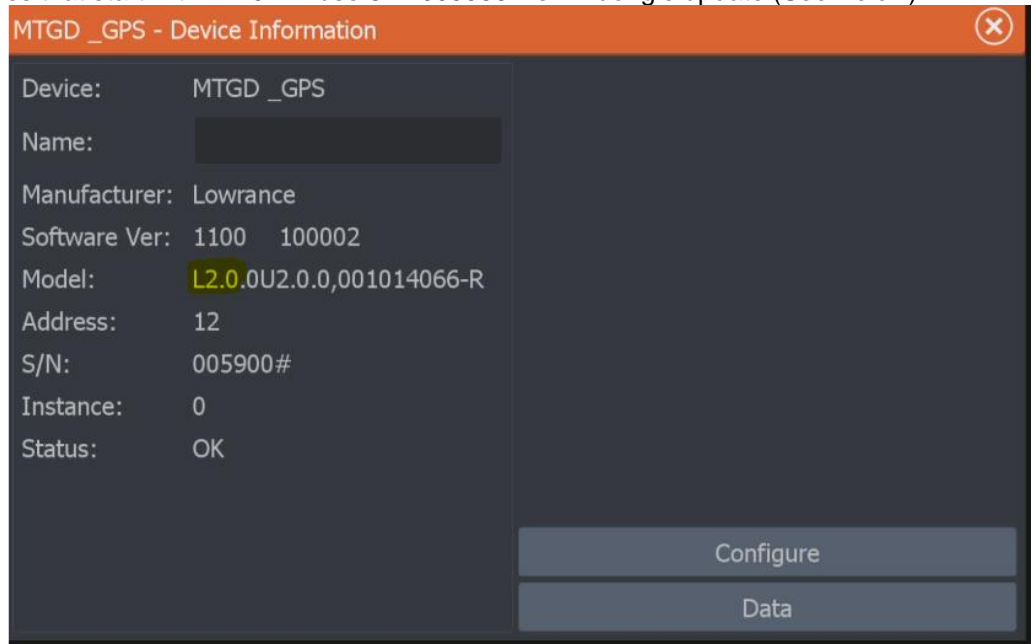
- Verify the MTGD_GPS Model Code on the Screen of the MFD. (Settings-Network-Device List-MTGD_GPS), Codes that start with L.2.0 will use 8M4005956 Rev A dongle update (See Below):
